**Flood Control Project Maintenance
Levee Inspections**

Fall 2011 Levee Maintenance Deficiency Summary Report

Sacramento River Basin

Levee District No. 0001 (Glenn County)

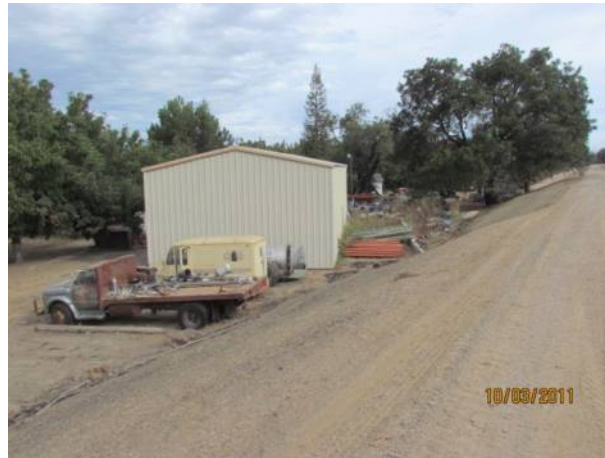
Levee Mile Report Line	1
Start Levee Mile	1.10
End Levee Mile	1.33
Location	Land Side
Category	Earthen Levee
Item	Encroachments

View of vehicles & equipment along the L/S toe.

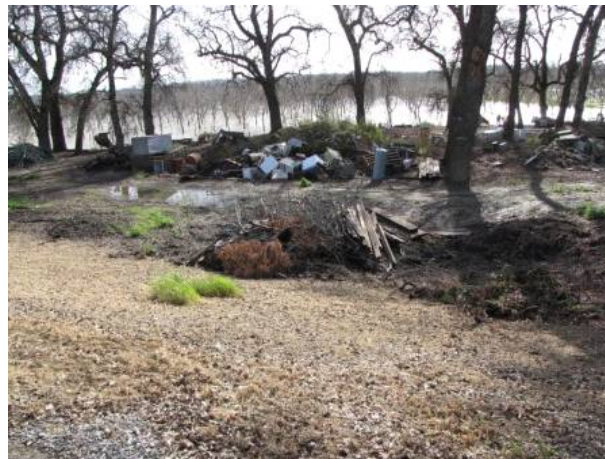
Levee Mile Report Line	2
Start Levee Mile	1.23
End Levee Mile	1.23
Location	Water Side
Category	Earthen Levee
Item	Encroachments

View of the debris & garbage along the W/S toe.

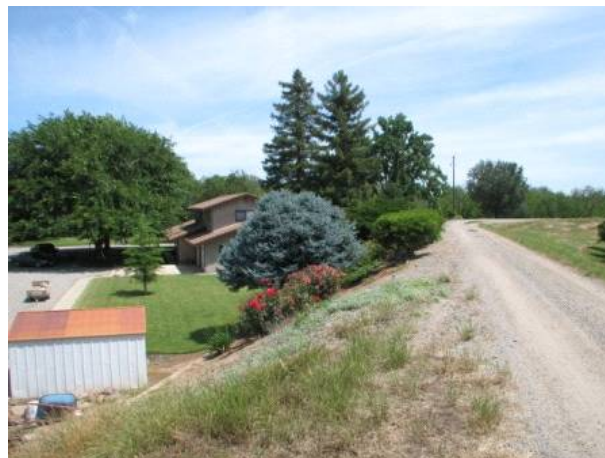
Levee Mile Report Line	3
Start Levee Mile	1.35
End Levee Mile	1.39
Location	Land Side
Category	Earthen Levee
Item	Encroachments

View of the permitted landscape on the landside slope of the levee.

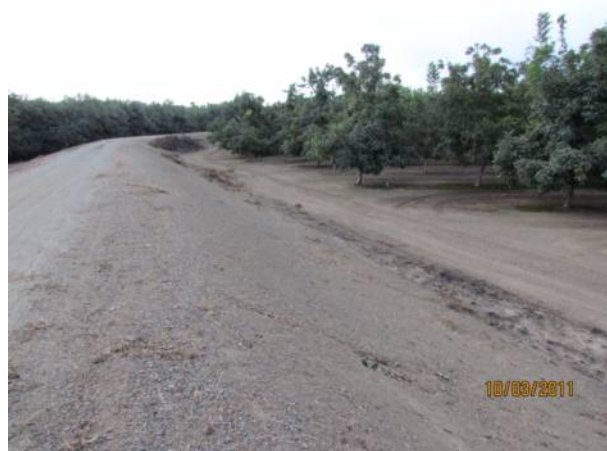
Levee Mile Report Line	5
Start Levee Mile	3.13
End Levee Mile	3.13
Location	Water Side
Category	Earthen Levee
Item	Animal Control

View of repaired rodent holes along the W/S slope.

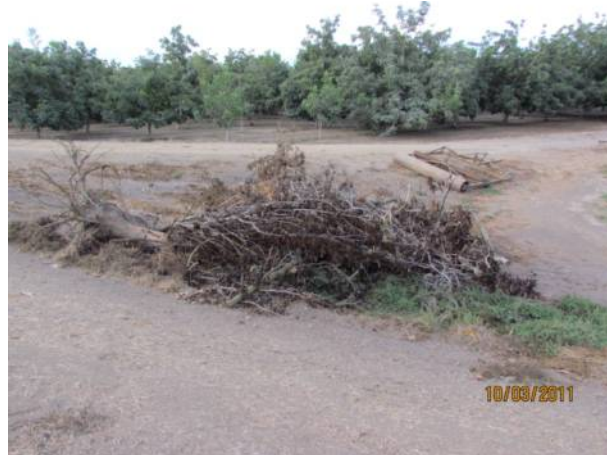
Levee Mile Report Line	7
Start Levee Mile	3.22
End Levee Mile	3.22
Location	Land Side
Category	Earthen Levee
Item	Encroachments

View of the prunings pile along the L/S toe.

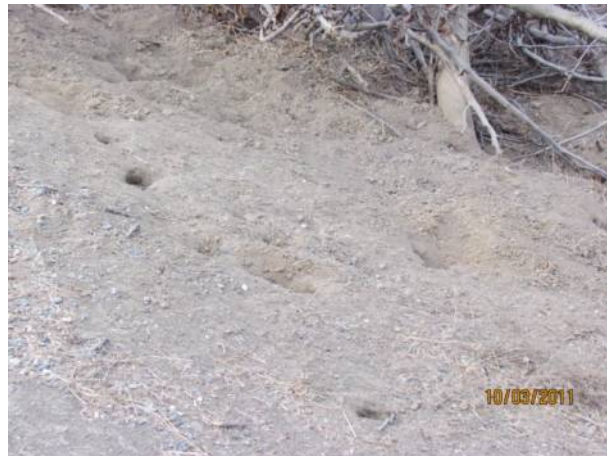
Levee Mile Report Line	10
Start Levee Mile	3.94
End Levee Mile	3.94
Location	Land Side
Category	Earthen Levee
Item	Animal Control

View of the rodent holes along the L/S toe.

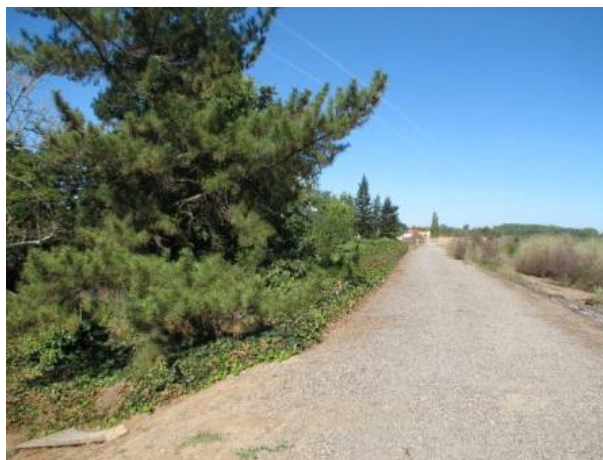
Levee Mile Report Line	16
Start Levee Mile	6.39
End Levee Mile	6.42
Location	Land Side
Category	Earthen Levee
Item	Encroachments

View of the permitted landscape along the landside slope.

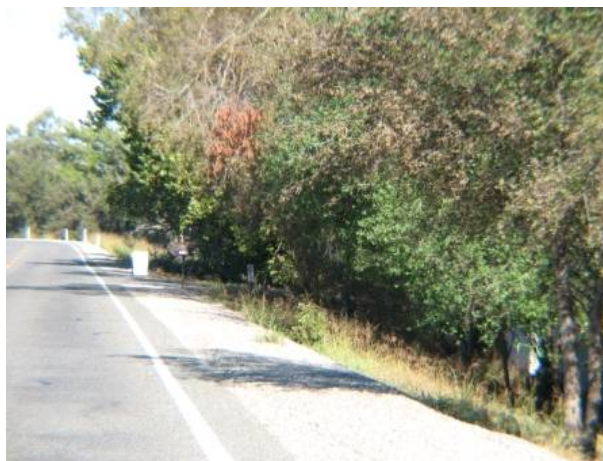
Levee Mile Report Line	18
Start Levee Mile	8.17
End Levee Mile	8.28
Location	Water Side
Category	Earthen Levee
Item	Trim / Thin Trees

View of the trees and vegetation along the waterside slope of the levee.

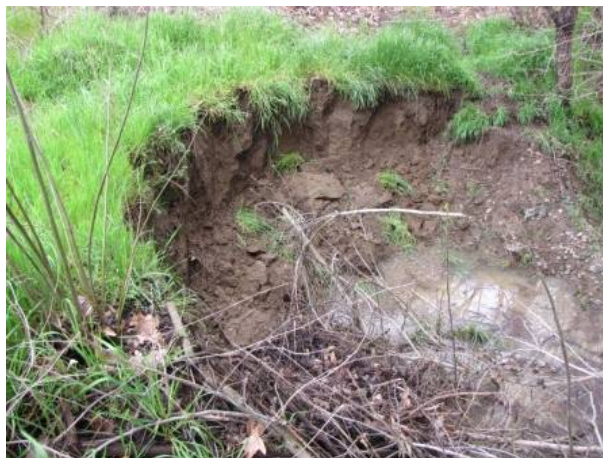
Levee Mile Report Line	19
Start Levee Mile	8.96
End Levee Mile	8.96
Location	Water Side
Category	Earthen Levee
Item	Erosion / Bank Caving

View of the erosion from the failed pipe.

LMR No.	Levee Mile		Category	Item	Location *	Rating **	Action/Comment	GPS Latitude/Longitude		Issue No.
	Start	End						Start	End	
19	8.96	8.96	Earthen Levee	Erosion / Bank Caving	WS	U	Schedule repair of erosion site prior to the next inspection.	39.587102 ° -122.005605 °	39.587102 ° -122.005605 °	7 Y
20	9.03	9.62	Earthen Levee	Vegetation	LS	C	Remove the wild growth other than native grasses from the levee slopes.	39.588028 ° -122.005321 °	39.595938 ° -122.002652 °	41
21	9.70	9.70	Earthen Levee	Encroachments	LS	M	Debris	39.597078 ° -122.002127 °	39.597078 ° -122.002127 °	11 Y
22	10.21	10.21	Earthen Levee	Animal Control	LS	M	Exterminate rodents and backfill and compact or grout burrows.	39.603211 ° -121.997176 °	39.607431 ° -121.994458 °	46 Y
23	10.65	10.69	Earthen Levee	Animal Control	LS	W	No rodents visible, but rodent burrows visible; need to backfill and compact or grout burrows.	39.608748 ° -121.993678 °	39.609355 ° -121.993628 °	12 Y

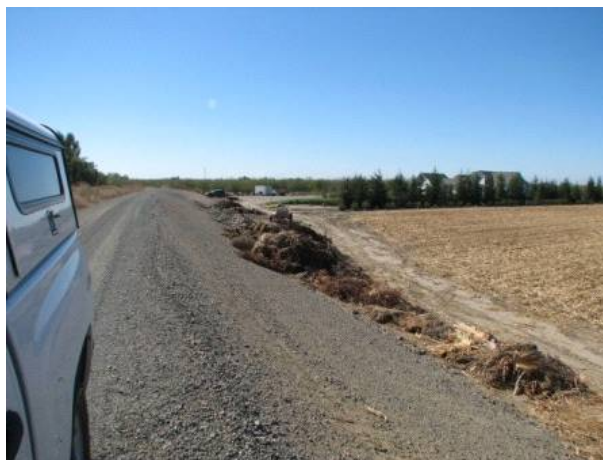
Levee Mile Report Line	21
Start Levee Mile	9.70
End Levee Mile	9.70
Location	Land Side
Category	Earthen Levee
Item	Encroachments

View of debris along the toe of the levee.

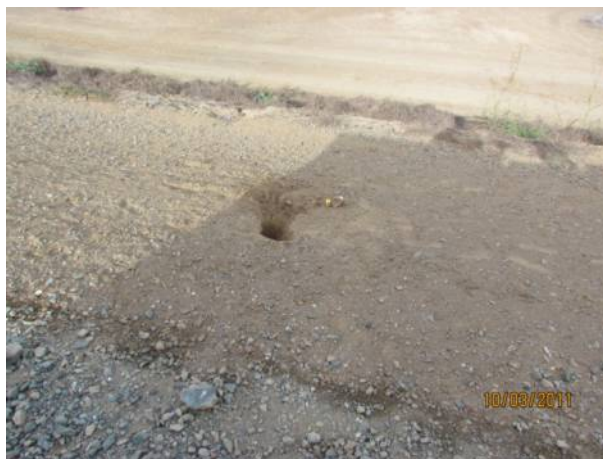
Levee Mile Report Line	22
Start Levee Mile	10.21
End Levee Mile	10.21
Location	Land Side
Category	Earthen Levee
Item	Animal Control

View of the rodent holes along the L/S slope.

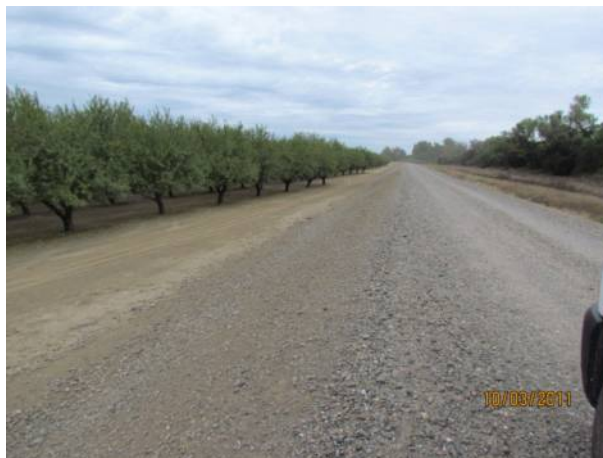
Levee Mile Report Line	23
Start Levee Mile	10.65
End Levee Mile	10.69
Location	Land Side
Category	Earthen Levee
Item	Animal Control

View of repaired rodent holes along the L/S slope.
